# MONITORING AND PREDICTING MASONRY'S CREEP FAILURE WITH THE ACOUSTIC EMISSION TECHNIQUE

Els Verstrynge <sup>a,\*</sup>, Luc Schueremans <sup>a</sup>, Dionys Van Gemert <sup>a</sup>, Martine Wevers <sup>b</sup>

<sup>a</sup>Department of Civil Engineering, KULeuven, Kasteelpark Arenberg 40, bus 2448, 3001 Heverlee, Belgium

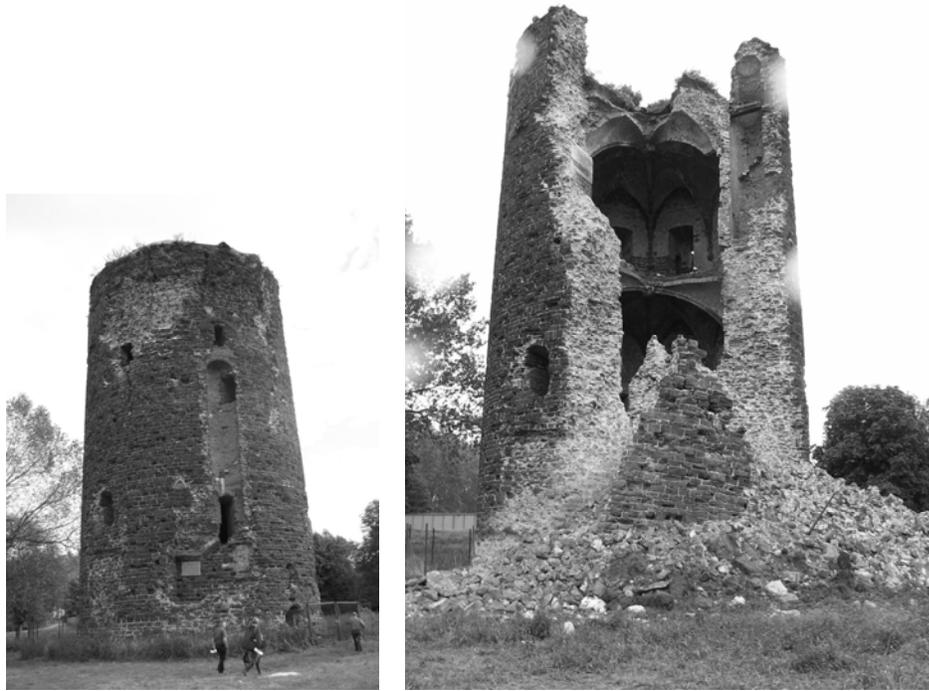
Fig. 1. Maagden tower at Zichem, Belgium, before and after collapse (June 2006)

The background of this research is the collapse of several historical masonry structures over the past decades due to time-dependent deformations caused by high, sustained loading [7, 8]. One of these structures is the Maagden tower, which partially collapsed on 1st of June, 2006 (see Fig. 1). No sudden disturbance of the acting forces, such as an earthquake, could be pointed out as having caused the collapse. The tower was composed of three-leaf masonry in sandstone, which appeared to be in a bad condition. A high dead load acted on the base of the tower, especially in the area where the cross-section of the wall was reduced by a staircase opening. It is at this point that the wall collapse was triggered [9]. These events have urged the research for non-destructive techniques which are able to detect unstable damage accumulation in masonry structures.

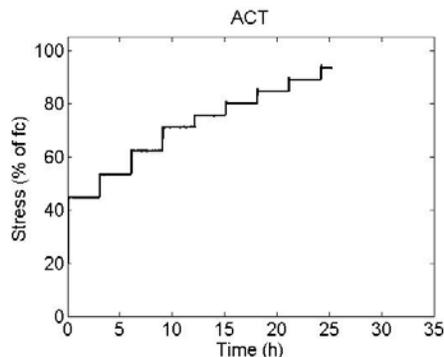
Fig. 2. Typical stress path followed during short-term creep test

Both types of creep tests, short-term as well as long-term, follow the same basic principles considering their test set-up. A stepwise increasing, axial load is applied on the specimens and the damage evolution in time is detected by monitoring the deformations and acoustic emissions as a function of time and stress level. A typical loading path, followed during an accelerated creep test (ACT) is indicated in Fig 2. The time interval between two stress increase steps is three hours. During the long-term creep tests, at least a two months interval was chosen. The stress levels are calculated as a certain percentage of the average compressive strength ( $f_c$ ). The compressive strength is obtained as the average value of the result of at least three monotonic compressive tests for each mortar composition respectively.

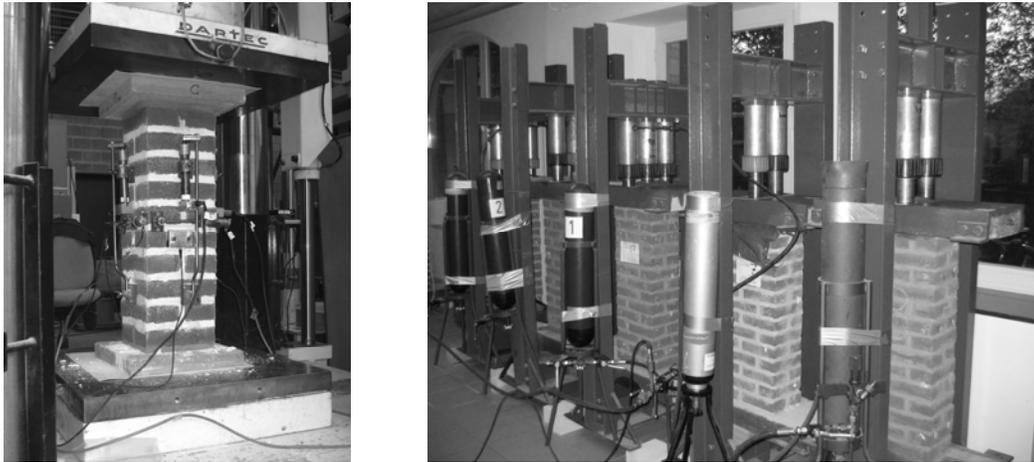
Fig. 3. Typical short-term (a) and long-term (b) creep test set-up

The duration of the creep test imposes certain restrictions on the testing and monitoring equipment used. For the accelerated creep tests, a test device, type Schenck Trebel RM 100, was used to apply the load. Additionally, one horizontal and one vertical Linear Voltage Displacement Transducers (LVDT) was installed on each side of the specimen (see Fig. 3a) to continuously monitor the strain evolution. The overall deformations were calculated as an average of all sides. Due to the extended duration of the long-term creep tests, separate steel frames were constructed for each test specimen and hydraulic jacks were used to apply the load (Fig. 3b). Removable mechanical strain gauges were used to measure the deformations periodically. On

each side of the masonry test specimens, four horizontal and six vertical measuring bases were installed.

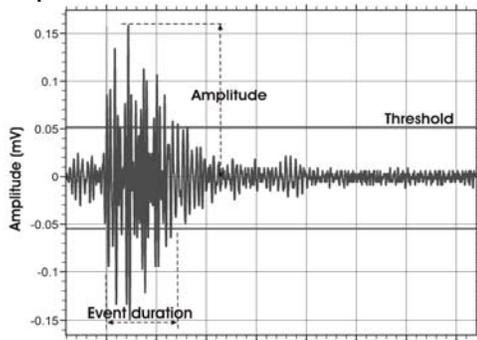
Fig. 4a. Main features of an AE signal (burst type)

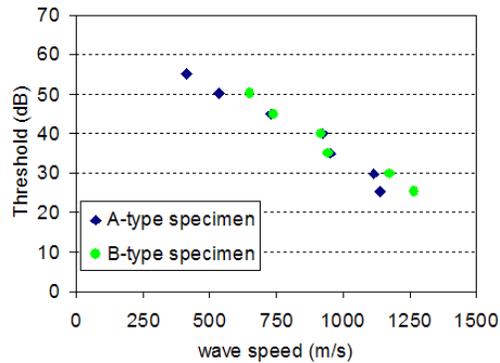
Fig. 4b. Dependency of wave propagation speed on threshold level for uncarbonated (A-type) and fully carbonated (B-type) specimens

The average wave velocity inside the accelerated creep test specimens ranges from 800 m/s (120 m/s standard deviation) for the not fully carbonated masonry to 1057 m/s (180 m/s standard deviation) for the fully carbonated masonry. The wave velocity is calculated using the distance between the source and the sensors and the travel time of the wave between the two sensors. So it also depends strongly on the threshold level, as the arrival time of a wave at a specific sensor is marked by the moment the threshold is exceeded. This dependency of the wave speed on the threshold was checked on two specimens and is indicated in Fig. 4b. The break of a pencil lead can be detected up to 30 cm from the sensor; again this distance depends on the lay-out of the bricks, the quality of the mortar-brick connection and the coherence of the masonry in general.

These preliminary verifications indicate that the majority of the damage sources in the specimen can be monitored by placing two sensors in the middle (as the height of the specimens is 60 cm). For all creep tests, a threshold level of 34.5 dB is used. The complexity of the material lay-out and wave propagation makes source location impracticable.

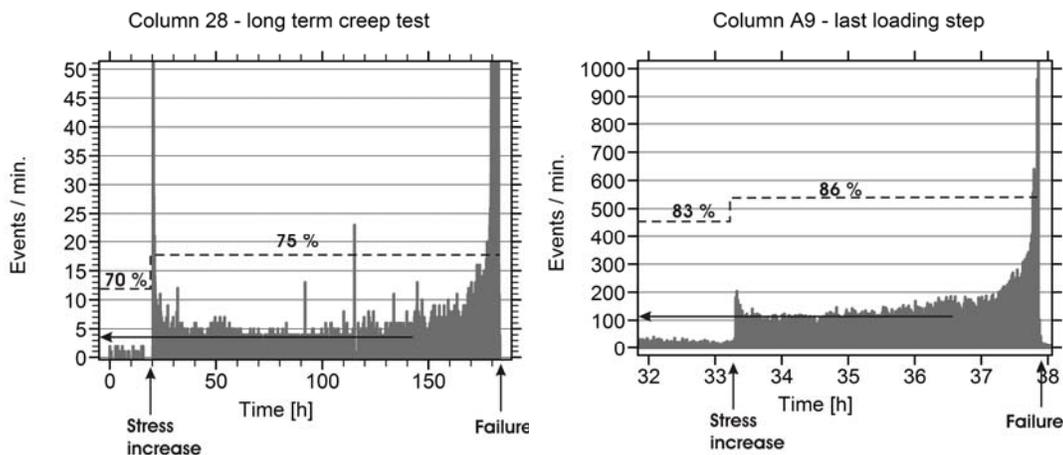
Fig. 5. AE event rate during final phase of long-term (a) and short-term (b) creep test

The result of a final stage of a long-term creep test is presented in Fig. 5a. A full description of the results of these tests was published before in [10]. The graph indicates the event rate (in events/minute) as a function of time. The peak value at the beginning of the curve indicates the moment at which the stress was increased to 75% of the compressive strength of the specimen. It has to be noticed that this compressive strength is the average strength obtained from compressive tests on three masonry specimens with the same composition. The stated 75% should therefore be seen as an estimated value. The stress path is indicated in Fig. 5 with a dotted line.

After the stress increase step, the event rate decreases to a low, almost constant value (indicated in Fig. 5 with a horizontal arrow), while the stress level is kept at a constant value. After five days, the event rate increases again and keeps rising until the specimen finally fails about one week after the stress increase. The moment of failure is indicated by the second peak value in the graph. As the event rate started increasing again about 50 hours before failure of the specimen, the unstable damage increase, which was a warning of the failure, could be detected more than two days before the actual collapse occurred.

For comparison, the result of a final stage of a short-term creep test is presented in Fig. 5b. In order to compare the results of this short-term creep test with the long-term test in Fig. 5a, the event rate is indicated on the same scale, in events/min. Again, the stress path is indicated with a dotted line and the stress is increased from 83% to 86% of the average compressive strength, obtained from compressive tests on similar specimens. The appearance of the curve is clearly related to the results of the long-term creep test. However, the secondary stage, with a low constant value, appears to be much shorter and shows a higher event rate. The acquisition of these results is rather complex, as many specimens do not show a significant tertiary creep phase during the short-term creep test, but fail during the stress increase itself. Other specimens fail shortly after the stress increase. They do demonstrate a resulting graph comparable with the ones shown here, but the secondary stage decreases and often,

only a small drop in event rate is visible in between the two peak values. The duration of the secondary stage and the minimum value for the event rate obtained appear to be correlated with the time to failure.

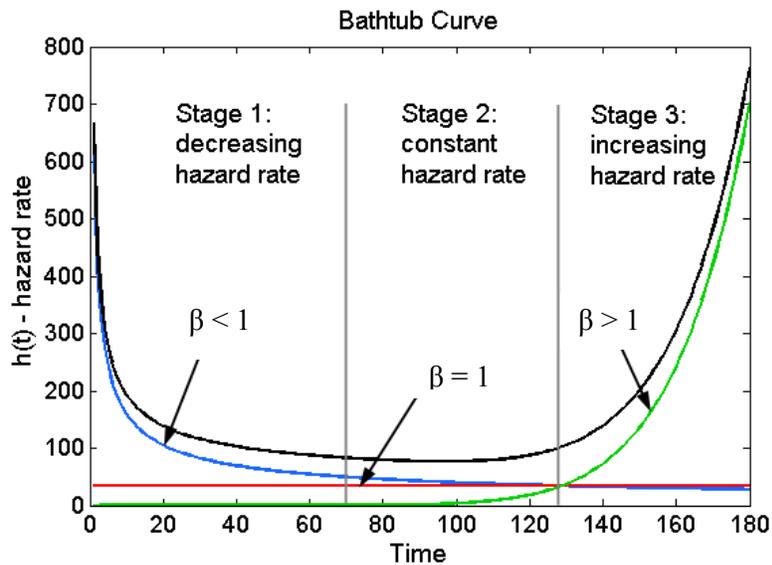
Fig. 6. Bathtub curve

The graph presenting the event rate as a function of time (Fig. 5a and 5b) can be described as a bathtub curve [12], as presented in Fig. 6. In reliability analysis, bathtub curves are often used to present the hazard rate in function of time. The curve has a first stage with a decreasing failure rate, known as the infantile or early-life failures, where the system is adopting to the new situation. The second stage shows a constant hazard and the third phase, also called the wear-out phase, an increasing failure rate. The bathtub curve has a broad field of application and can be described by the Weibull function:

The shape parameter,  $\beta$ , also called the Weibull slope parameter determines the slope of the Weibull probability density function (pdf) and enables the three stages of the bathtub curve to be described (see Fig. 6):

- $\beta < 1$ : describe a decreasing failure rate
- $\beta = 1$ : describe a constant failure rate, the Weibull pdf reduces to an exponential distribution
- $\beta > 1$ : describe an increasing failure rate

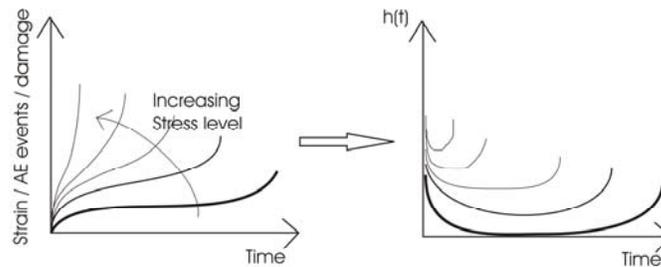
Fig. 7. Derivation of bathtub shaped curve from creep curves

The duration and the hazard rate of the second stage of the bathtub curve depend on the stress level. The higher the stress level, the higher the frequency of local failures ( $\frac{1}{\eta}$ ) and the shorter the duration of this stage will be. This can be clearly observed from the typical diagram in Fig. 7. When higher sustained stresses are imposed on the masonry, shorter and steeper creep curves are obtained. This is translated into a shorter second stage of the bathtub curve as the latter can be seen as the derivative of the creep curve. The Y-axis in Fig. 7 indicates strain, as well as cumulative AE events or damage accumulation. As was indicated before in [10], there is a straightforward relation between these observable parameters. To quantify the dependence between time and hazard rate for the presented creep tests, the relation between the AE event rate during the second phase and the time to failure of the specimens was investigated.

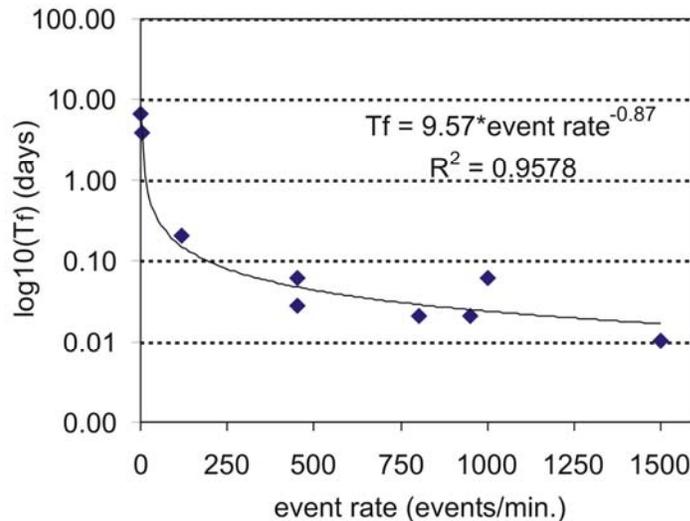
Fig. 8. Relation between time to failure ( $T_f$ ) and minimum AE event rate

of a long-term creep test program. The minimum event rate during the secondary phase of these tests was plotted in relation to the failure time ( $T_f$ ) of the specimens. The results are shown in Fig. 8.

A power law relation is found between the minimum event rate during the second stage of the bathtub curve and the time to failure of the specimen after the last stress increase step. The largest time to failure obtained during the laboratory tests was approximately one week. The relationship found here could be extrapolated to longer failure times or, in other words, to masonry subjected to lower stress levels. Unfortunately, two questions rise when this extrapolation would be done in order to assess the failure time while monitoring a structure.
